SERVICE BULLETIN

APL-SB20

Applicability: Propeller Models: AP431/3CTF-WWR66U used on ULPower 350iS engine
Serial Numbers: 1111,1345, 1354,1355,1427, 1468, 1567, 1572, 1843

SUBJECT: HUB AND BLADE THRUST BEARING INSPECTION

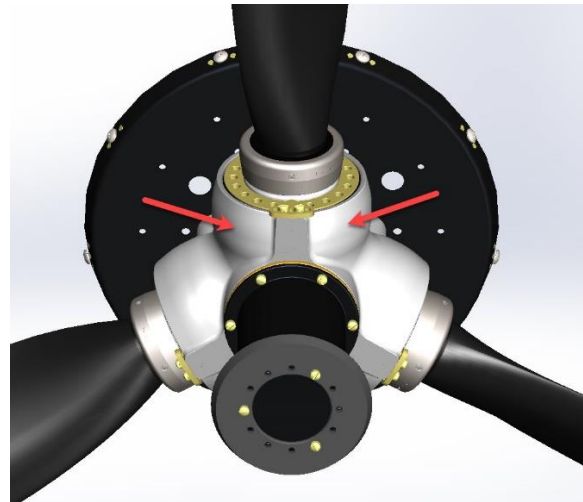
⚠ Caution Pay particular attention to the area around the top of each blade boss, ~0.75in(20mm) from the face of the boss.

📌 Note A crack will appear as a thin red line in the white paint running around the circumference of the boss.

2. If a crack is detected (or suspected), or if bearing damage is evident, the propeller should be removed from service and returned to Airmaster Propellers Ltd (New Zealand) for inspection. There is no charge for this service (shipping charges still apply).
3. If no cracks are found and no bearing damage is evident, then this information should be relayed to Airmaster propellers, along with the following:
 - a. Customer contact information, Hub serial, Hrs in service.
 - b. Photo of bearing condition.

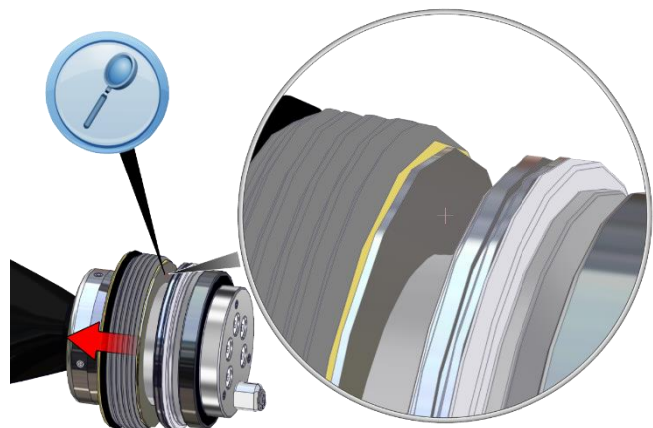
- Slide retention nut towards ferrule nut and separate top thrust bearing washer from thrust bearing pack.
- Wipe grease off washer (use clean rag or cotton bud).
- Inspect surface of thrust bearing washer and check for damage or unacceptable wear as shown below.

📌 Note Damage will appear as indentations in the bearing washer surface. Please send a photo showing condition.

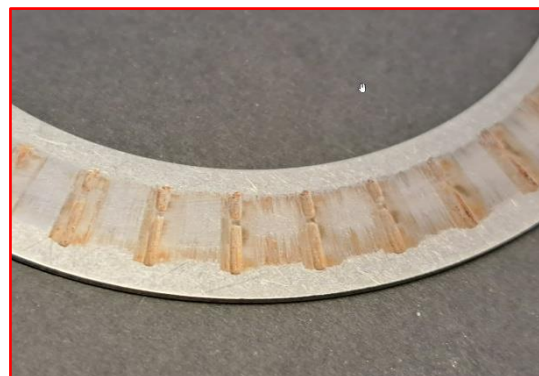
**Unacceptable** condition:

- Heavy indentations visible.

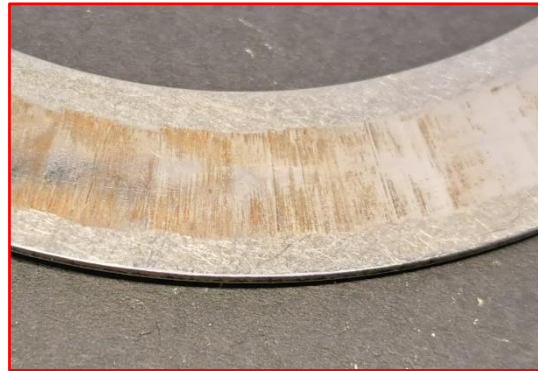
Unacceptable condition:

- Light indentations visible.

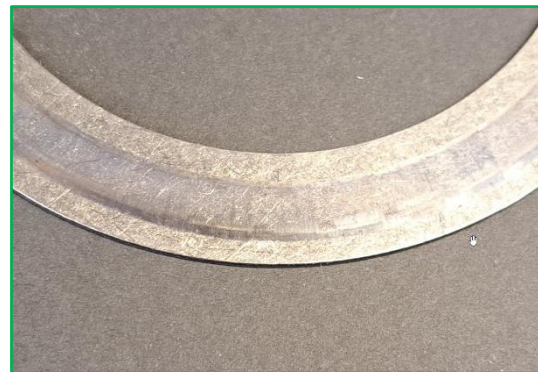
**Acceptable** condition:

- Normal wear pattern, no indentations visible.
