# SERVICE BULLETIN

## APL-SB21

### SUBJECT: SENSENICH BLADE PAINT INSPECTION

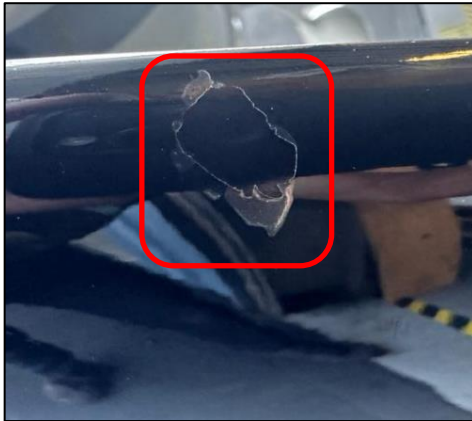
Airmaster has received report of a potential paint defect affecting a batch of Sensenich blades that use a painted black finish. This defect causes the blade's clear coat to peel from the black painted surface during service. The type of blades affected are 72K and 70E Sensenich blades (Airmaster blade assembly no. AB-SNR72K(BW)-xxx, and AB-SNR70E(BW)-xxx). This is a cosmetic defect, not an airworthiness issue.

**Unacceptable** condition: Clear coat peeling from black painted surface of blade.

2. If paint damage is detected (or suspected), report findings to Airmaster propellers immediately using the inspection record supplied at the end of this document, as well as providing photos of blade condition.
  - a. The affected set of blades should be removed from service and returned to Sensenich Propellers (USA) for paint refurbishment (shipping charges apply).
3. If no paint damage is evident, then this information should be relayed to Airmaster propellers using the inspection record attached, alongside photos of blade condition.
4. Visual inspections of the propeller blades should be carried out every 25hrs until further notice.

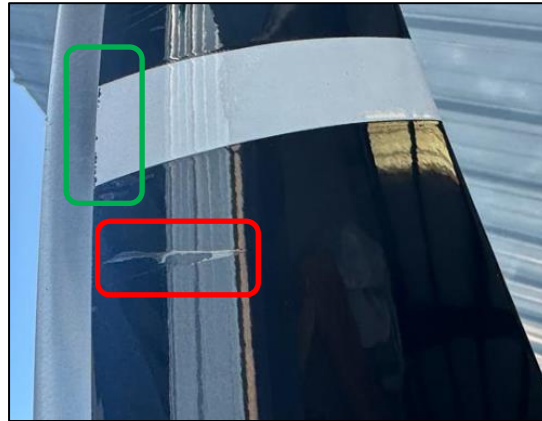
**Acceptable** condition: Note that slight wear on white stripe (right) is normal wear and tear on propeller blade.

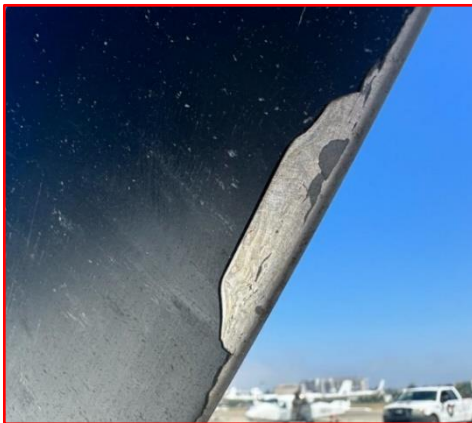
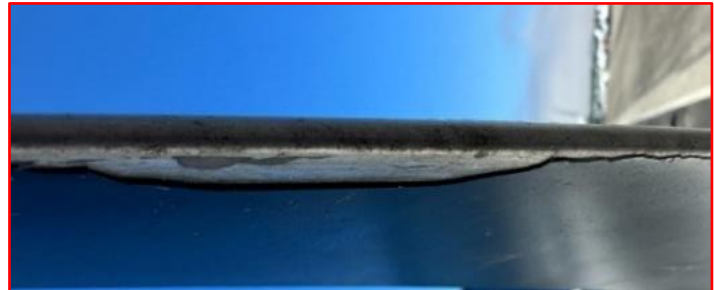
**Unacceptable** condition: Paint flaking off underside of leading-edge of blade.
