# Aero Trading Ltd

## SERVICE BULLETIN

### ATL-SB-2

**SUBJECT: PREVENTION OF WATER INGRESS INTO HUB**

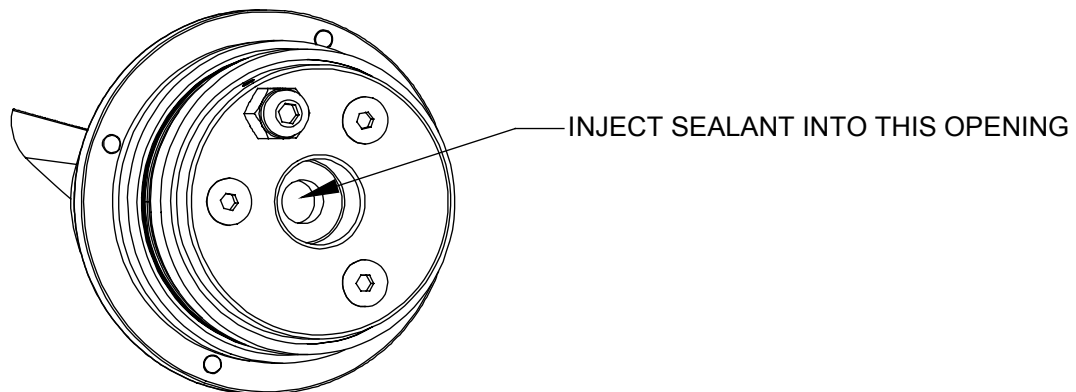
**Figure 1 – Position of Sealant in Blade Assembly**

1. Airmaster propellers with Warp Drive blades may suffer from water ingress while the propeller is stationary, by the entry of rainwater through the blade ferrules. Water is able to pass down the shank of the Warp Drive blade, through the gaps between the blade retention sleeves into the ferrule. Through the open inner end of the ferrule, the water is then able to enter the hub.

6. Using a suitable gun or nozzle inject sealant into the opening at the inner end of the cam-follower attachment spigot so that it enters the cavity formed by the butt of the blade, the blade ferrule and the cam-follower attachment spigot. See the following diagram for details of this.
