Airmaster Propellers Ltd

SERVICE BULLETIN

APL-SB-14

SUBJECT: SEALING OF BLADE ASSEMBLIES TO PREVENT WATER INGRESS INTO HUB

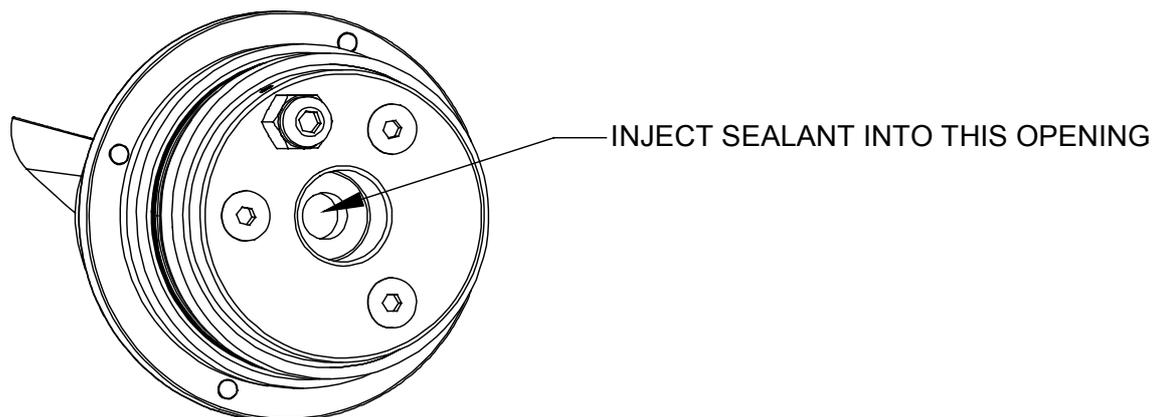
3. Some early production examples of the AP308 propeller (approximately up to a manufacture date of mid 2000, and approximately up to a serial number of 50) have an earlier design revision of the cam-follower attachment spigot. This earlier design revision allows water ingress to the hub via different paths. This earlier design revision may be identified by a circular recess in the face of the spigot, through which the butt of the Warp Drive blade may be seen.

4. This service bulletin (APL-SB-14) does not address water ingress through the blade assemblies with the earlier design revision spigots, and should not be actioned on affected propellers.
5. Service bulletin ATL-SB-2 covers sealing of blade assemblies with the earlier design revision spigots, and operators of affected propellers should ensure that this service bulletin has been actioned. This may be determined by checking that the hole through the centre of the spigot is sealed by sealant material.

**Figure 1 - Illustration from Service Bulletin ATL-SB-2:
Showing Blade Assembly with Earlier Design Revision Spigot
and Hole that should be Sealed by Sealant**

6. However, service bulletin ATL-SB-2 does not exclude all paths of water entry, and it is recommended that operators of affected propellers use the propeller blade cover supplied in May 2001 whenever the aircraft is parked outside.

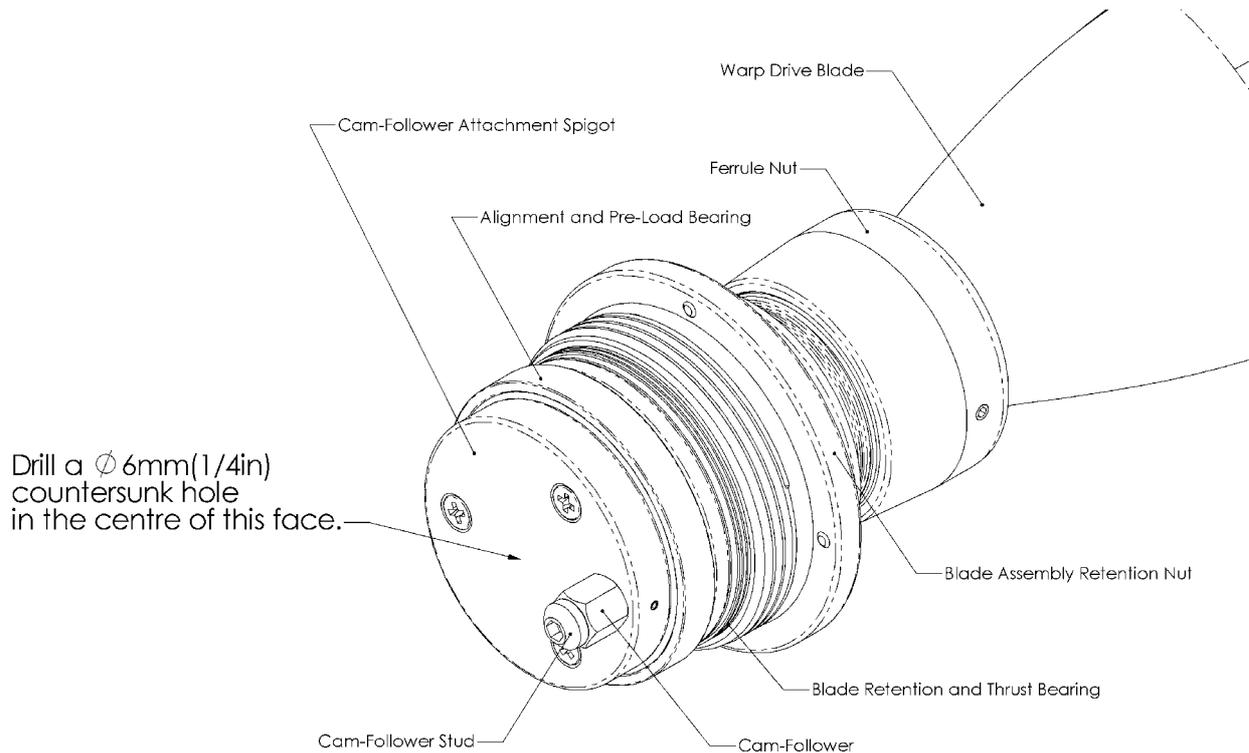
Figure 2 - Blade Assembly showing Required Location of Countersunk Hole

10. Drill a 6mm (1/4in) hole in the centre of the inboard face of the cam-follower attachment spigot as indicated in the following diagram. Material thickness at this point is 4mm of aluminium before the drill bit will enter a cavity. Countersink the hole to ensure a smooth edge, as this face of the cam-follower attachment spigot is a sliding surface against the plastic pitch change slide.

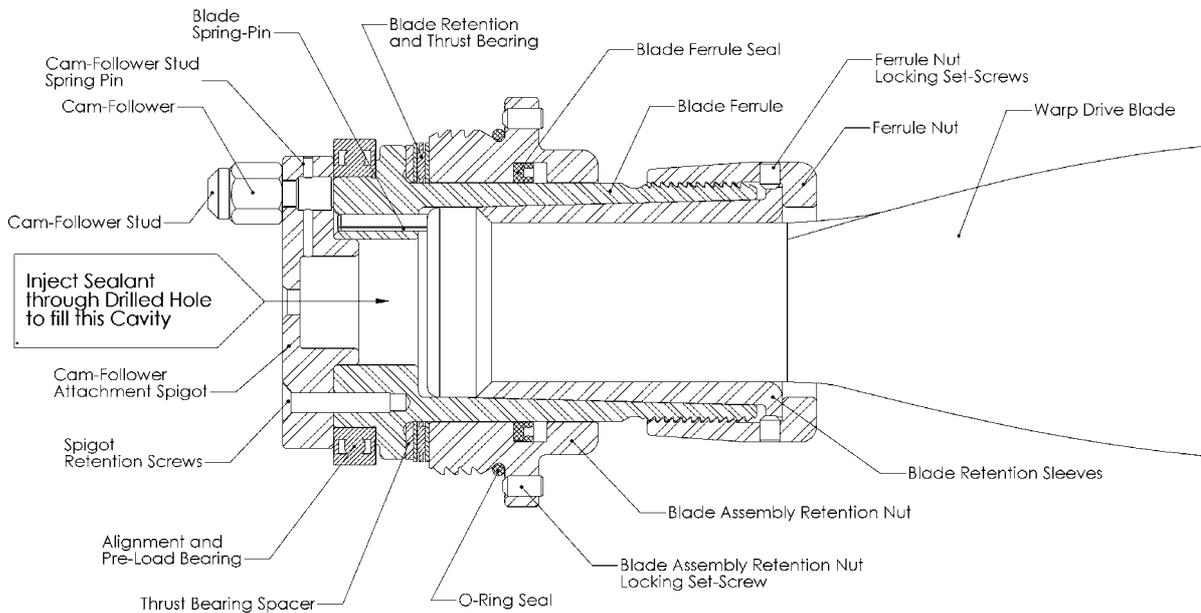
1. Airmaster AP308 propellers may suffer from water ingress while the propeller is stationary. Water, such as that from rain, is known to be able to enter the blade assembly through the annular gap between the shank of the Warp Drive blade and the ferrule nut. The water then passes down the two gaps between the blade retention sleeves and enters a cavity enclosed by the blade, the blade ferrule and the cam-follower attachment spigot. From this cavity water is able to enter the propeller hub, primarily by passing through the hole for the small spring-pin that retains the cam-follower stud.
2. This service bulletin addresses sealing of this blade cavity and the paths that allow movement of water from the cavity to the propeller hub.

**Figure 3 - Cross-Section of Blade Assembly
Showing Hole Drilled through Cam-Follower Attachment Spigot,
and Cavity to be filled with Sealant**

12. Push nozzle of sealant gun firmly into the hole drilled through the face of the spigot. Inject sealant into the cavity behind the spigot as indicated in the diagram below until one of the following is observed:

13. Approximately 25g (1 fl.oz.) of sealant will be required to fill the cavity. The sealant should completely fill the cavity, blocking the path of water through the cam-follower stud spring-pin, the blade spring-pin, and through the joint between the blade ferrule and the cam-follower attachment spigot. It is not necessary that sealant also extrude past the butt of the Warp Drive blade, into the area occupied by the blade retention sleeves.
