SERVICE BULLETIN

AP-SB16

Applicability: Propeller Models: AP332 models used on Jabiru engines
Serial Numbers:

SUBJECT: UPGRADE OF AP332 FERRULE COMPONENT WHEN USED ON JABIRU ENGINES

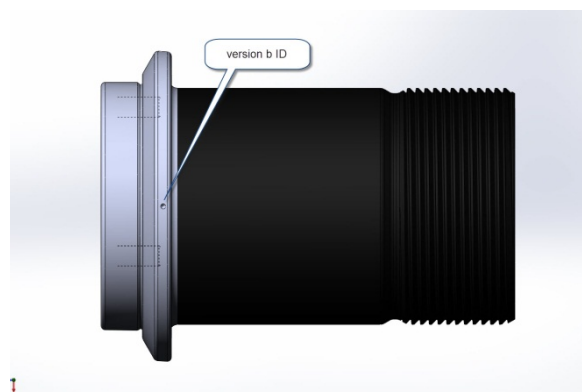
Airmaster has received reports of cracks appearing in the ferrule component of models AP332 when used on Jabiru engines. The cracks have been located at the base of the ferrule component, in the area where the ferrule body flares to the flange.

Airmaster have revised the ferrule component (AP-P0074b), and changed its material to increase its fatigue life. The revised ferrule type can be identified by a dot placed on the perimeter of the ferrule flange.

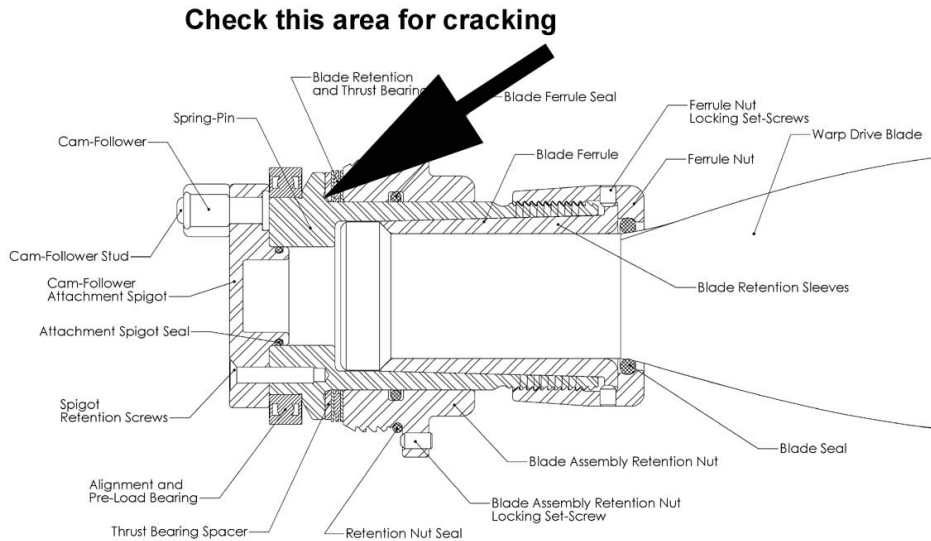
- a. Inspect the blade ferrule for cracking or corrosion. Pay particular attention to the fillet area between the flange at the inner end of the ferrule and the main cylindrical section of the ferrule, as this is the principal load bearing area. Inspect this area closely under good illumination.

Note: This area of the ferrule may be seen by sliding the blade assembly retention nut, the blade retention and thrust bearing, and the aluminium spacer towards the outboard end of the ferrule. After wiping away excess grease, the fillet area to be inspected will be exposed. A matt finish will be observed on the area, where the surface has received a shot peen treatment to enhance its fatigue properties.

Note: It is normal to see some marks where the retention bearing sits against the ferrule body. This should be cosmetic only.

2. If a crack is detected (or suspected), all three blade assemblies should be returned to Airmaster for ferrule replacement. There is no charge for this service (shipping charges still apply).
3. If no cracks are found, then this information should be relayed to Airmaster propellers, along with the following,

4. Airmaster advises that even if no cracks are detected during inspection, it is still recommended to apply the ferrule upgrade at the soonest possible time.
