SERVICE BULLETIN

APL-SB18

Applicability: Propeller Models: ALL AP332S models with steel retention components manufactured up to Nov 2019

SUBJECT: GREASE SEEPAGE FROM RETENTION NUT SEAL

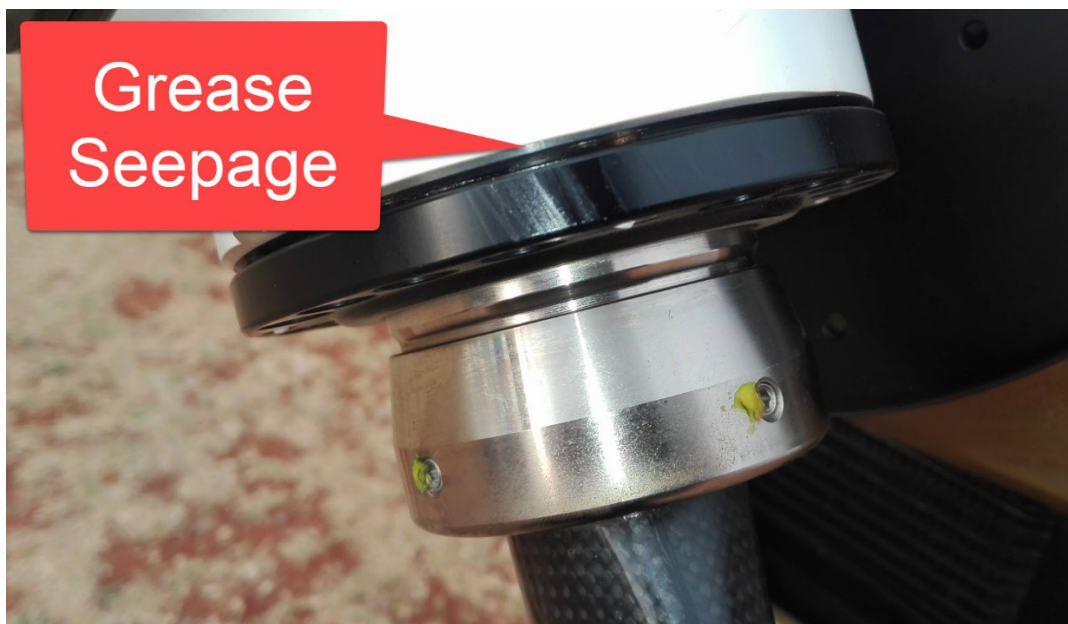
Some customers of the AP332S model have noted a small seepage of grease emanating from the area between the retention nut and the hub on new or relatively new propellers.

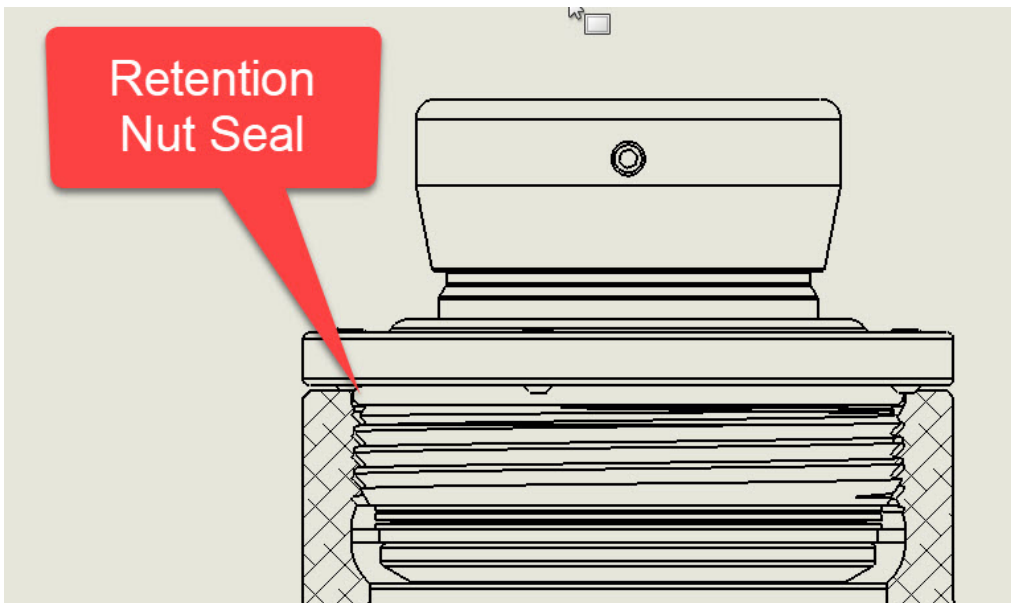
Upon investigation it has become apparent that a cumulative tolerance stack up on all the retention components has led to the possibility that the O-ring seal may have insufficient engagement into the hub counterbore to properly retain the grease from escaping.

There are two possible solutions to this problem. O-ring replacement or thrust bearing spacer replacement. Only one of the two solutions needs to be carried out.

1. The o-ring (P0194) sealing between the retention nut and the hub can be replaced with one that is slightly larger (P0414-232). The increased interference from the larger o-ring will form an effective seal.

2. The thrust bearing spacer (P0047) can be upgraded to the next revision of this part (P0047 r1A -> P0047 r2). The thinner section of the new part will allow the retention nut to seat more deeply in the hub bore and allow the existing seal to reach its proper engagement.
