SERVICE BULLETIN

APL-SB18

Applicability: Propeller Models: ALL AP332S models with steel retention components manufactured up to Nov 2019

SUBJECT: GREASE SEEPAGE FROM RETENTION NUT SEAL

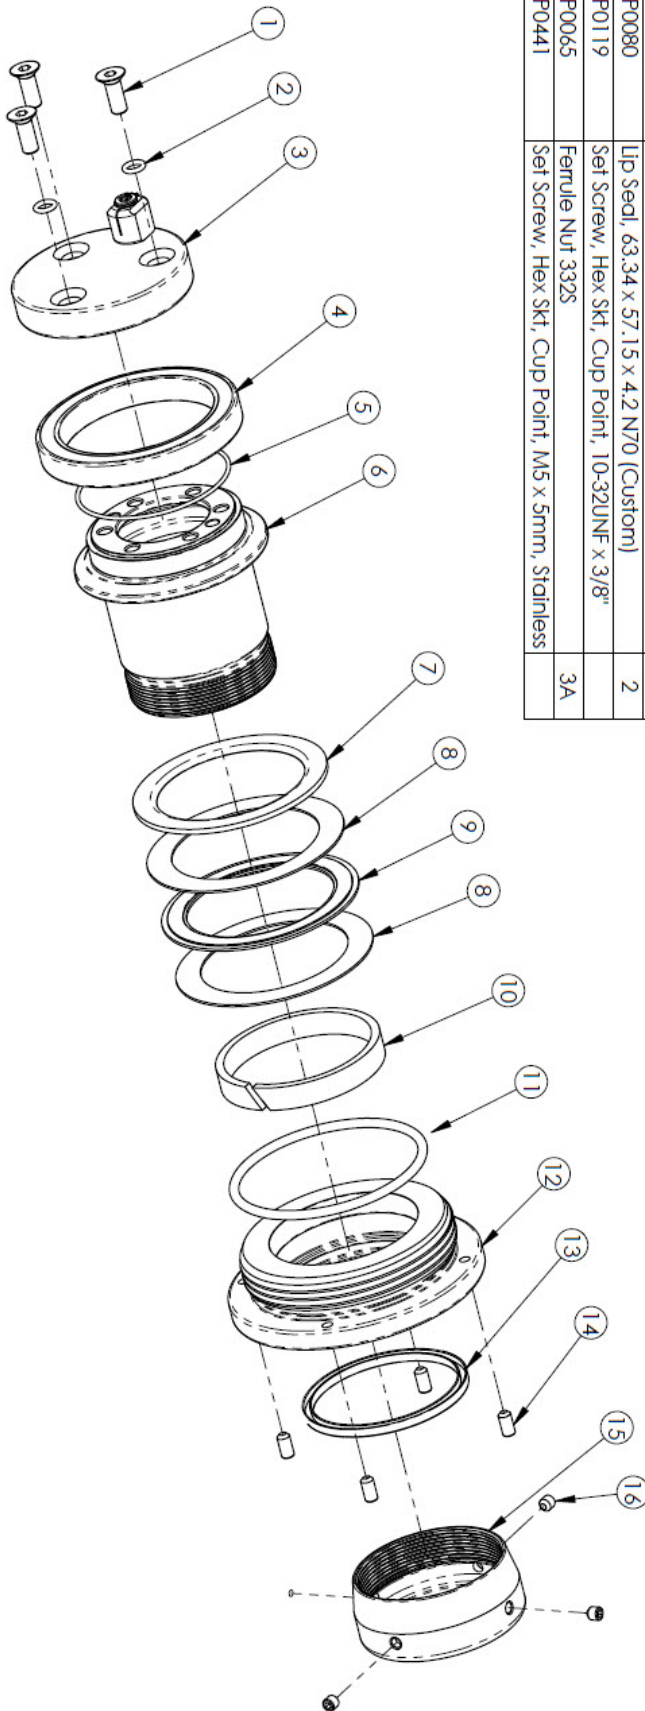
ASSY FILE: Blade Retention 332S Assy		REV: 3B	3B	O Ring changed as per SB-18	18/10/19	BOM	<p>Airmaster Propeller Ltd 201 Hazard Rd, Manurewa PO Box 374, Kumeu Auckland, New Zealand Ph: +64 9 833 1794 Email: support@propeller.com Web: www.propeller.com</p>
DRG FILE: A0320 Blade Retention 332S BOM			3A	P0080 to Rev 2	07/01/19		
ASSY NO: A0320			3	O Rings added	11/09/17		
DESCRIPTION: Blade Retention 332S Assy			2	Lip seal added	11/11/16	COPYRIGHT RESERVED ©	<p>The information contained in this drawing is the sole property of Airmaster. Any reproduction in part or whole without written permission of Airmaster is prohibited.</p>
			1	Original	07/01/13

1. The o-ring (P0194) sealing between the retention nut and the hub can be replaced with one that is slightly larger (P0414-232). The increased interference from the larger o-ring will form an effective seal.
